NAVAL POSTGRADUATE SCHOOL
Monterey, California

COMBAT DAMAGE ASSESSMENT TEAM
A-10/GAU-8 LOW ANGLE FIRINGS
VERSUS
SIMULATED SOVIET TANK COMPANY
(10 MARCH 1978)

August 1979

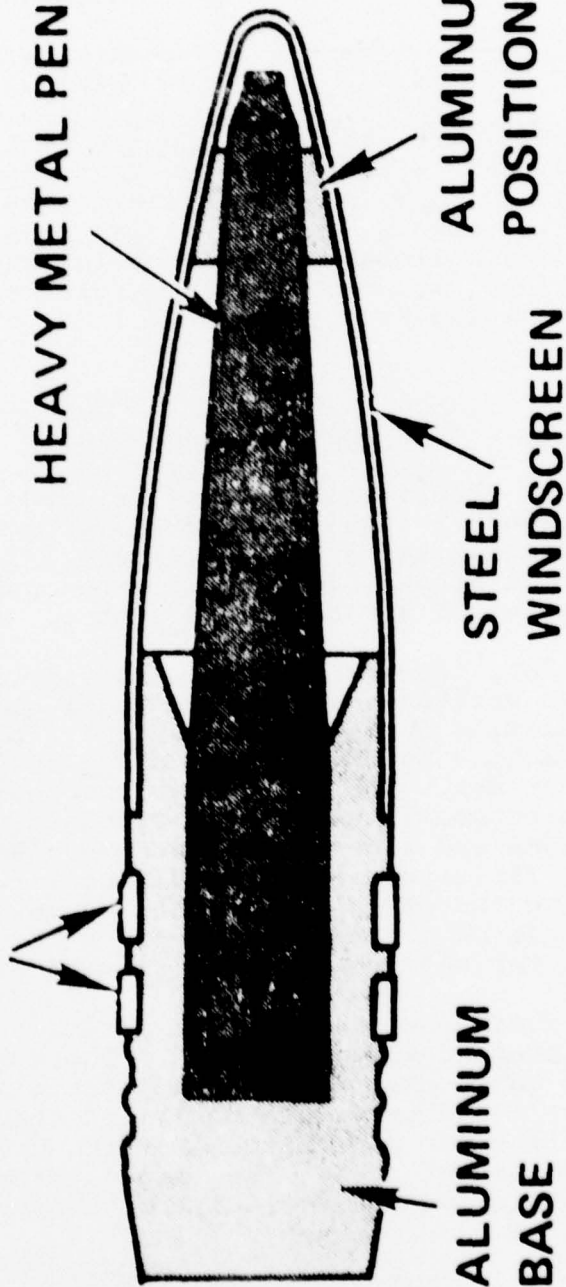
Figure 2. -- GAU-8 30mm API Ammunition: Projectile Sketch and Round Characteristics

API
PGU-14B

PLASTIC ROTATING BANDS

HEAVY METAL PENETRATOR

ARMOR PIERCING INCENDIARY (API)

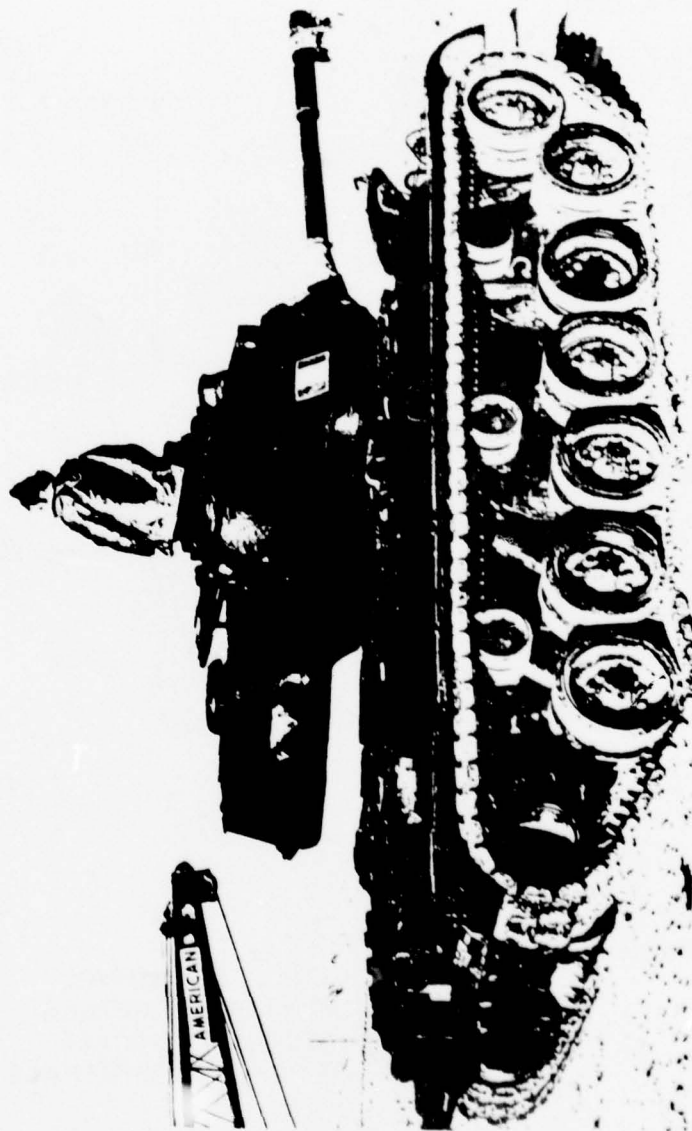
Figure 5. -- UNITED STATES M-47 COMBAT TANK

The most effective targets available in sufficient numbers to simulate Soviet T-55 and T-62 tanks were US M-47 tanks. Both of the Soviet tank models are similar in armor

The M-47 tanks used in the firing test, although generally similar in survivability to Soviet T-55 and T-62 tanks, can be contrasted as follows. The rear surfaces of the US and Soviet tanks are significantly different, with the most important contrast being the large overhang on the US vehicle. The overhang in combination with the attacked stowage box and the lack of ammunition in the turret would seem to make the M-47 tanks particularly invulnerable to K-Kills associated with perforations through the rear of the turret. First, the rear of the US turret is difficult to perforate because of the heavy gauge steel stowage box and second, perforating projectiles and spall must traverse several feet of inert components before contacting either crew members or stowed ammunition.

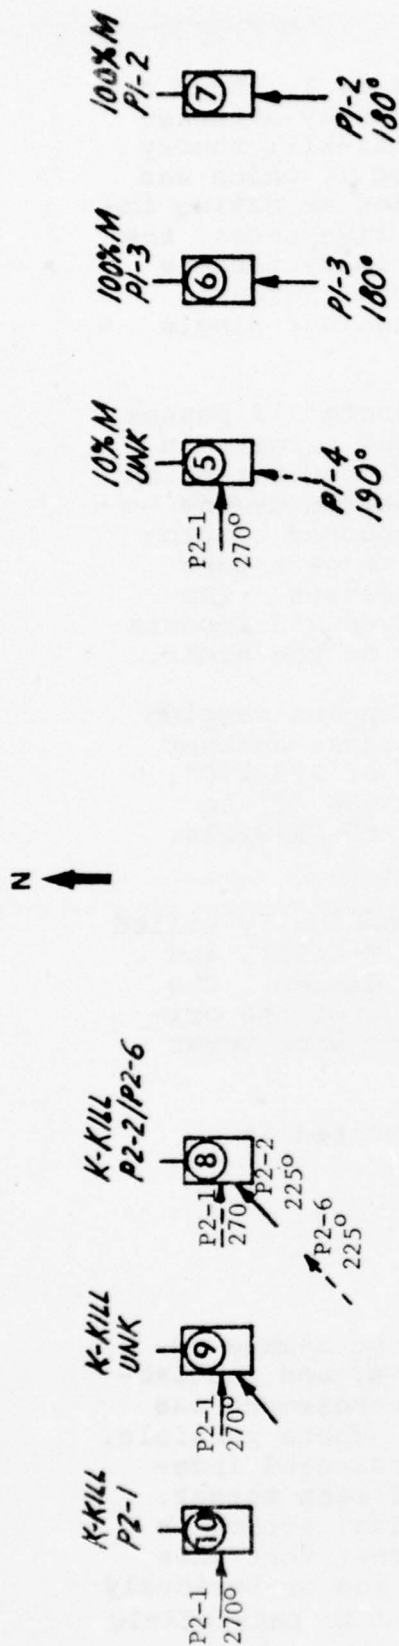
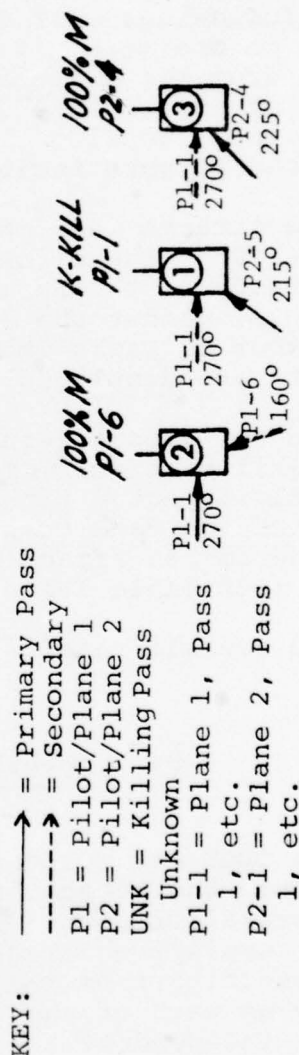
Figure 7 - - Primary, Secondary or Incidental, and Unidentified Passes

NOTE: The pilots were restricted in their attacks to a sector of 90-270° magnetic, hence, the concentration of attacks in that 180° sector.

KEY:
 → = Primary Pass
 ---→ = Secondary
 P1 = Pilot/Plane 1
 P2 = Pilot/Plane 2
 UNK = Killing Pass
 Unknown
 P1-1 = Plane 1, Pass 1, etc.
 P2-1 = Plane 2, Pass 1, etc.

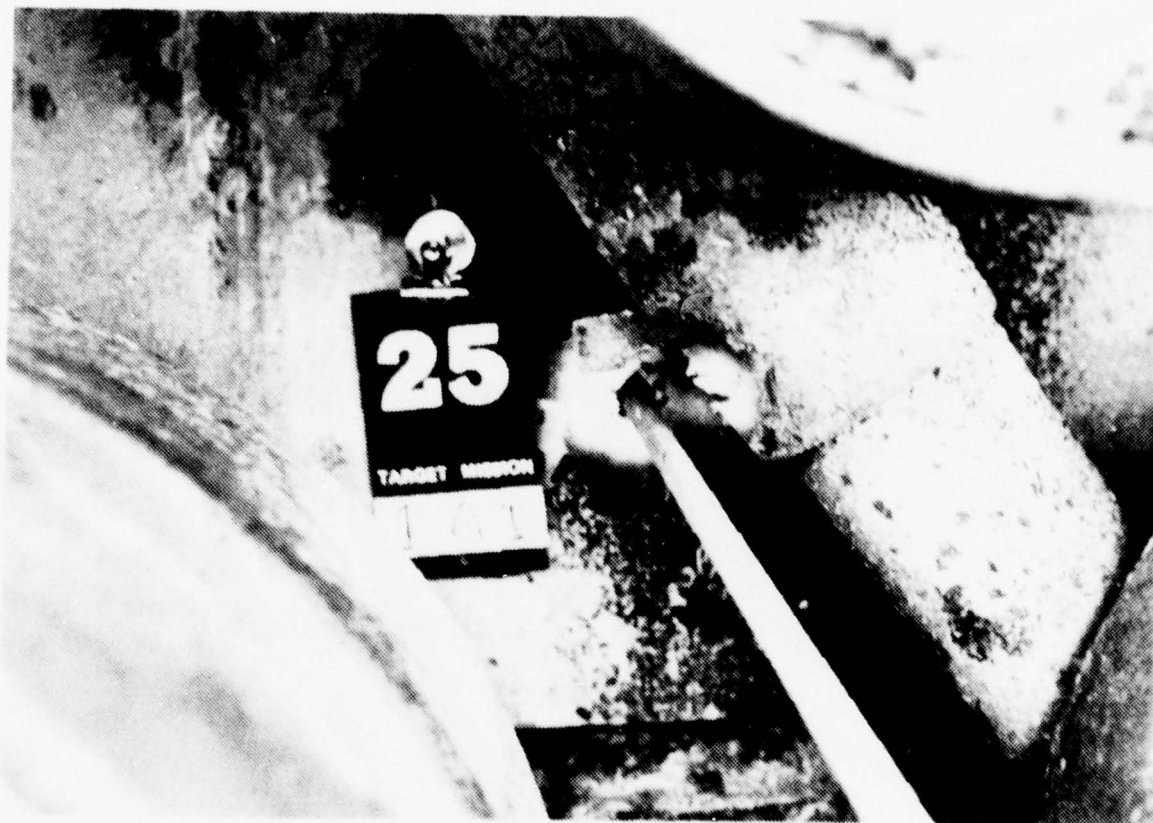
1. Description: Attacked during passes P1-1, P2-5, and one unidentified pass. Kill attributed to P1-1.
2. Kill Assessment: 100% K-Kill resulting from the following effects:
 - a. Perforations: 7
 - b. Significant Damage: Omitted - Catastrophic fire and explosion overrides other damage.
 - c. Insignificant Damage: Omitted - Catastrophic fire and explosion overrides other damage.
3. Multiple Pass Assessment: Not possible
4. Rationale for Kill Assessment: 100% K-Kill due to a fuel fire resulting from Impact 25 (Figure 8) which could not be extinguished by the crew because of casualties inflicted by Impacts 5 and 6 (Figure 9), and 16 (Figure 10).

FIGURE 8 - TARGET 1
IMPACT 25, PERFORATION OF LEFT HULL AND PENETRATION INTO LEFT
FUEL TANK

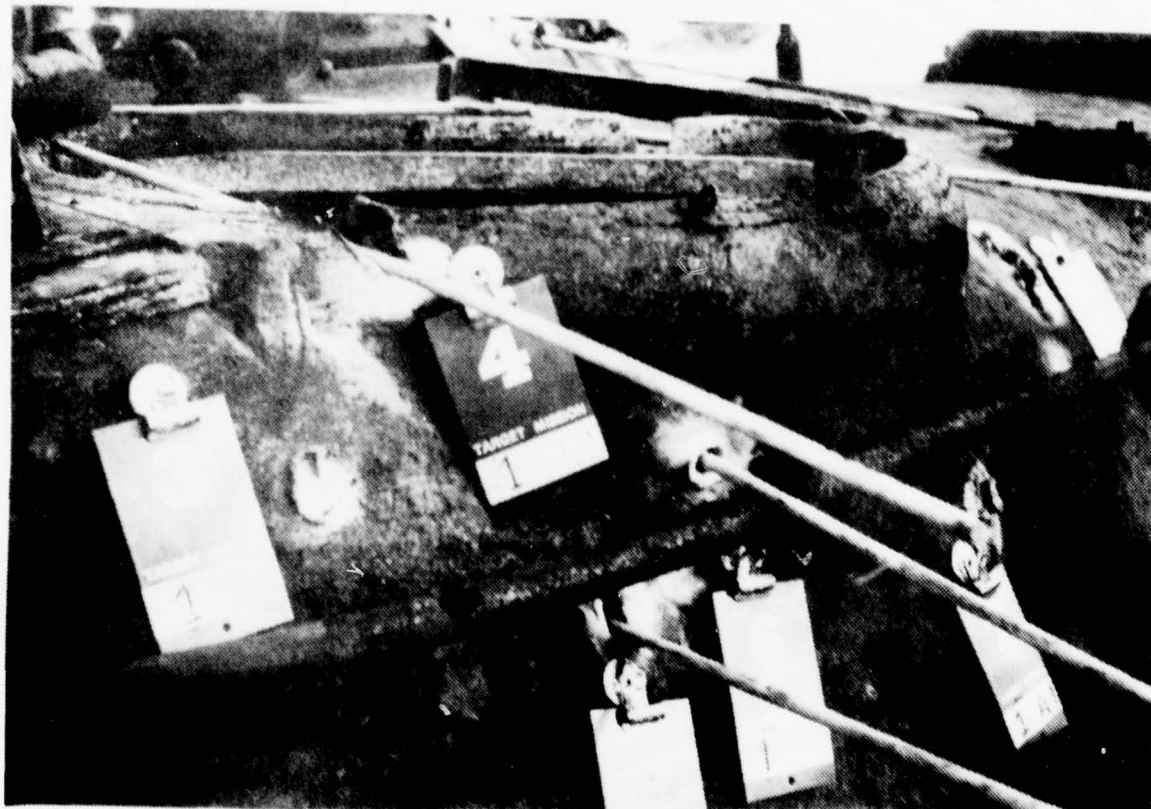
FIGURE 9 - TARGET 1
IMPACTS 5 and 6, PERFORATIONS OF LEFT TURRET INTO FIGHTING
COMPARTMENT

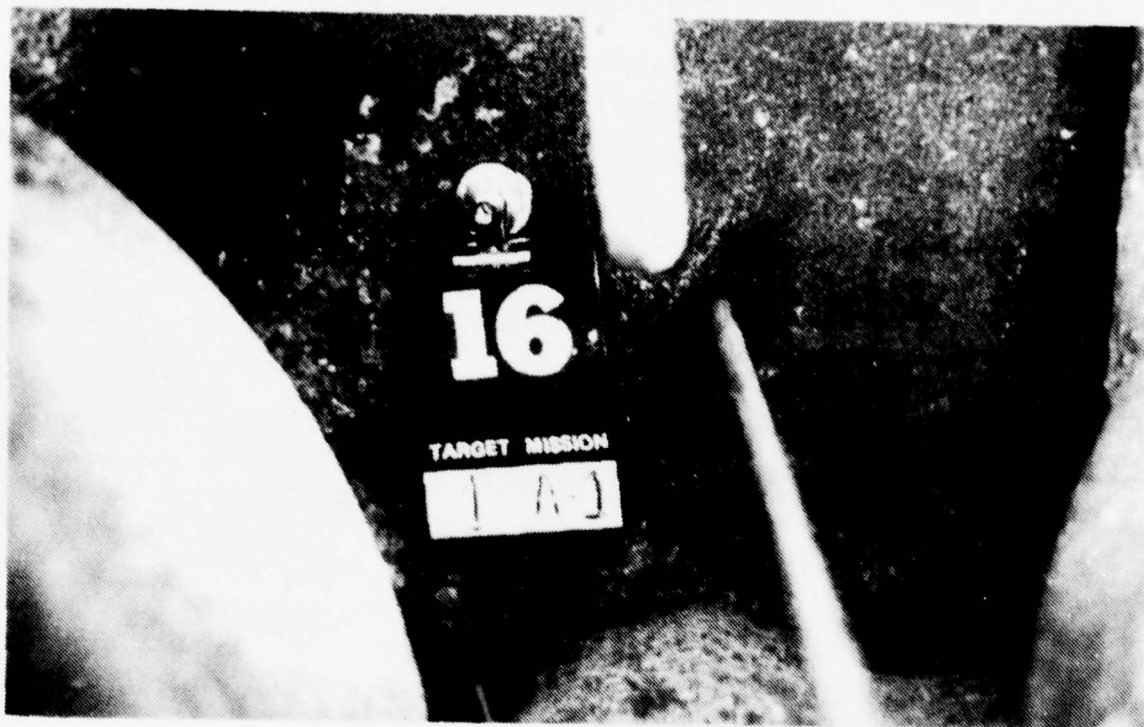
FIGURE 10 - TARGET 1
IMPACT 16, PERFORATION OF LEFT HULL INTO DRIVER'S COMPARTMENT

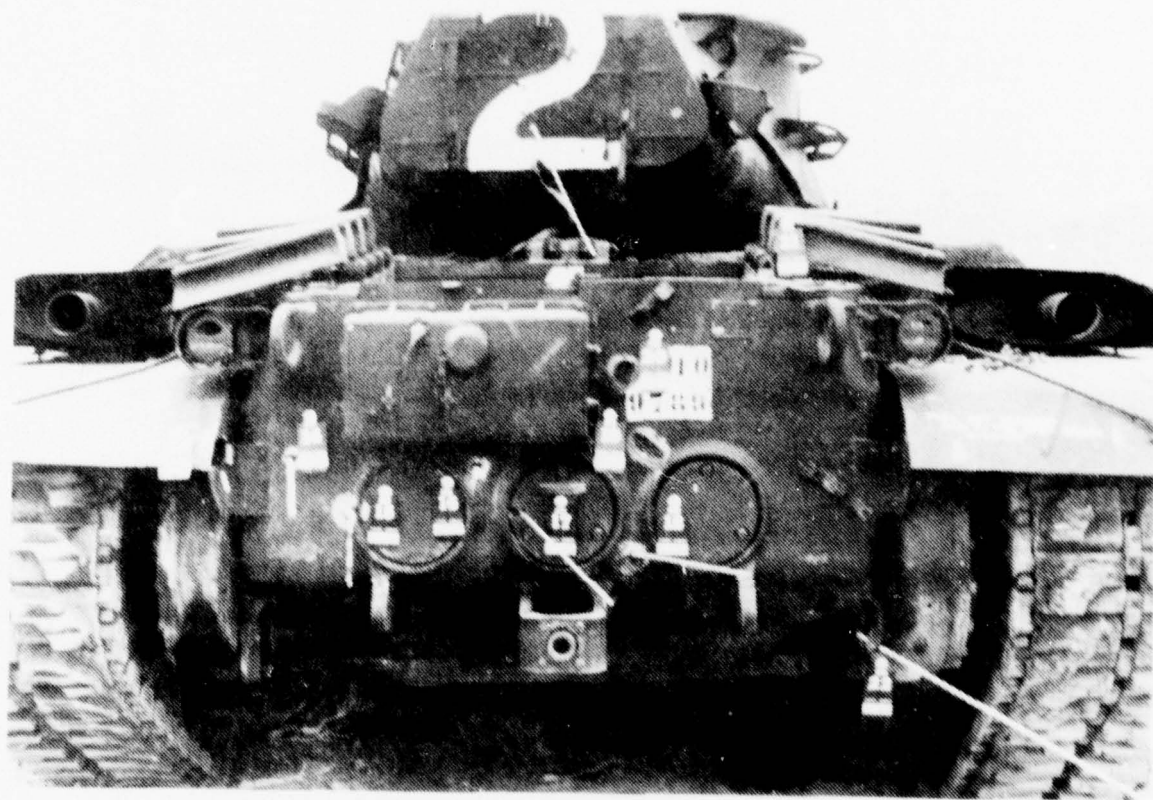
- a. M-Kill: 100% M-Kill due to transmission damage
resulting from Impacts 16 and 18 (Figure 11)
- b. F-Kill: 95% F-Kill due to crew casualties (sole
survivor criteria) inflicted by Impacts 1 and 3
(Figure 12) and to Impacts 4 and 5 (Figure 13)
which penetrated the gun tube.

FIGURE 11 - TARGET 2
IMPACTS 14, 15, 16 and 18, PERFORATIONS OF REAR HULL INTO
ENGINE COMPARTMENT

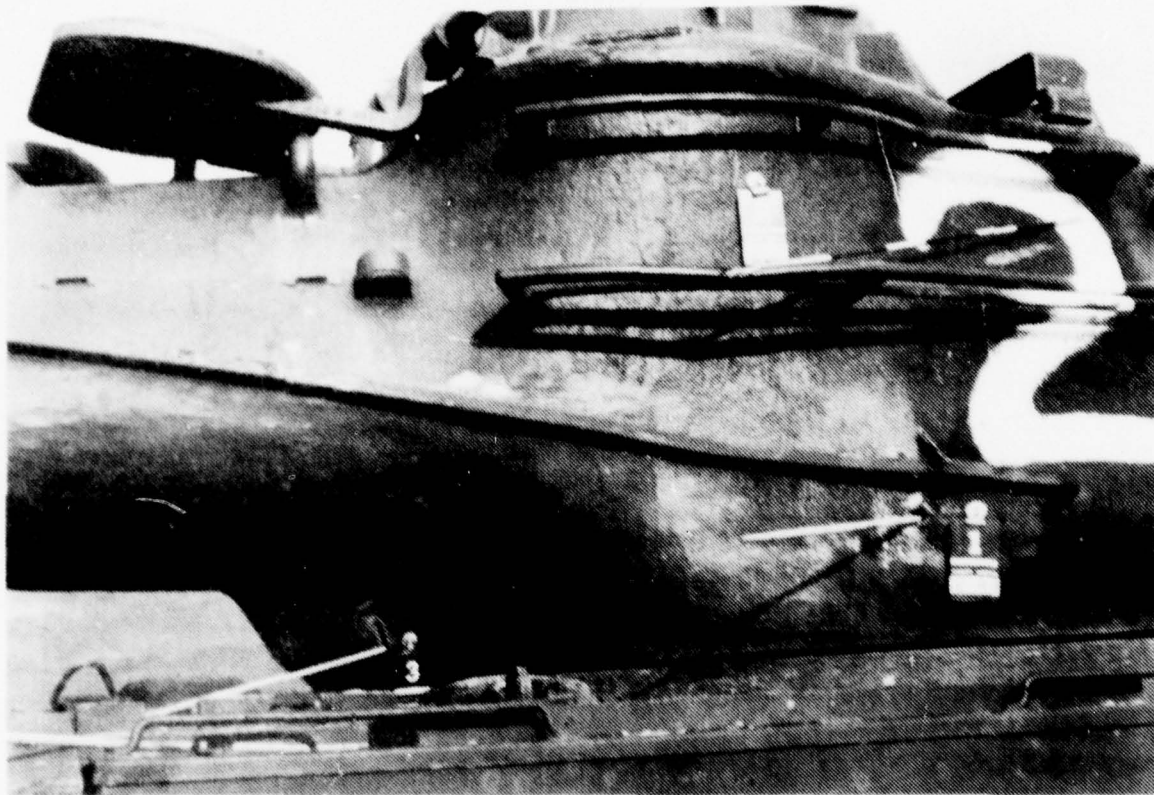
FIGURE 12- TARGET 2
IMPACTS 1 and 3, PERFORATIONS OF RIGHT TURRET INTO FIGHTING
COMPARTMENT

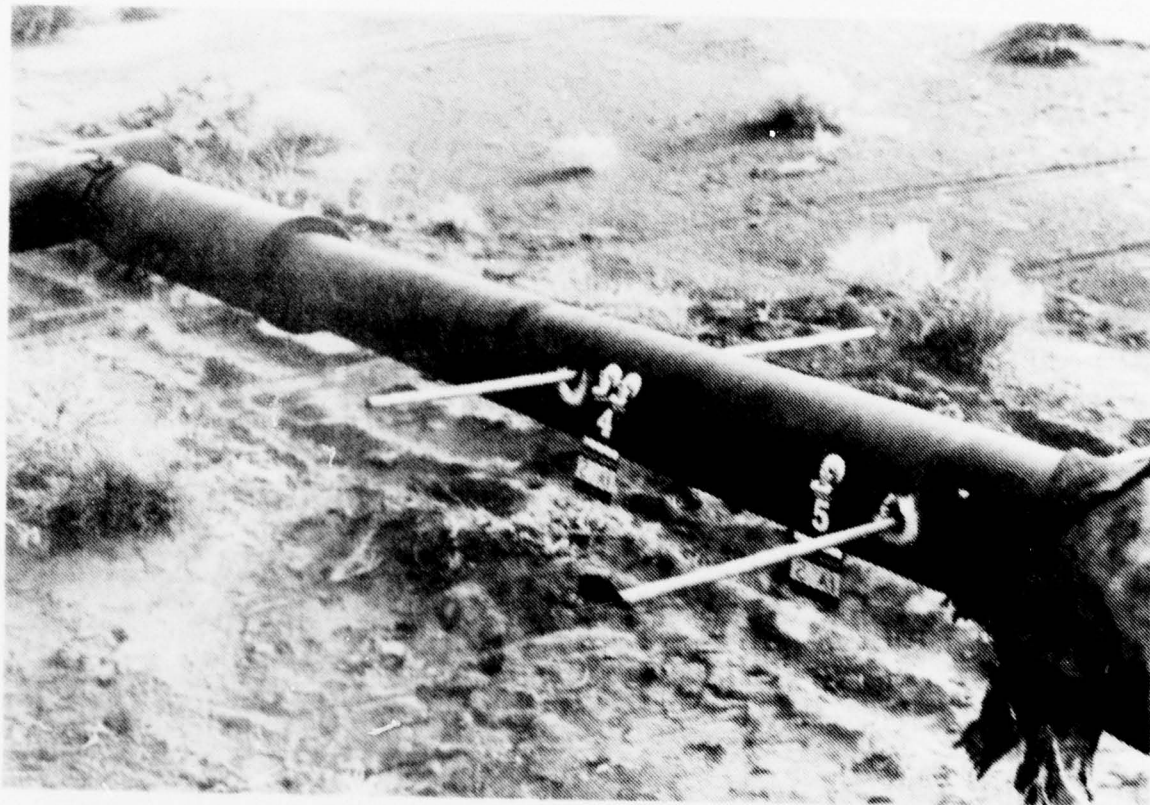
FIGURE 13 - TARGET 2
IMPACTS 4 and 5, PENETRATIONS THROUGH GUN TUBE

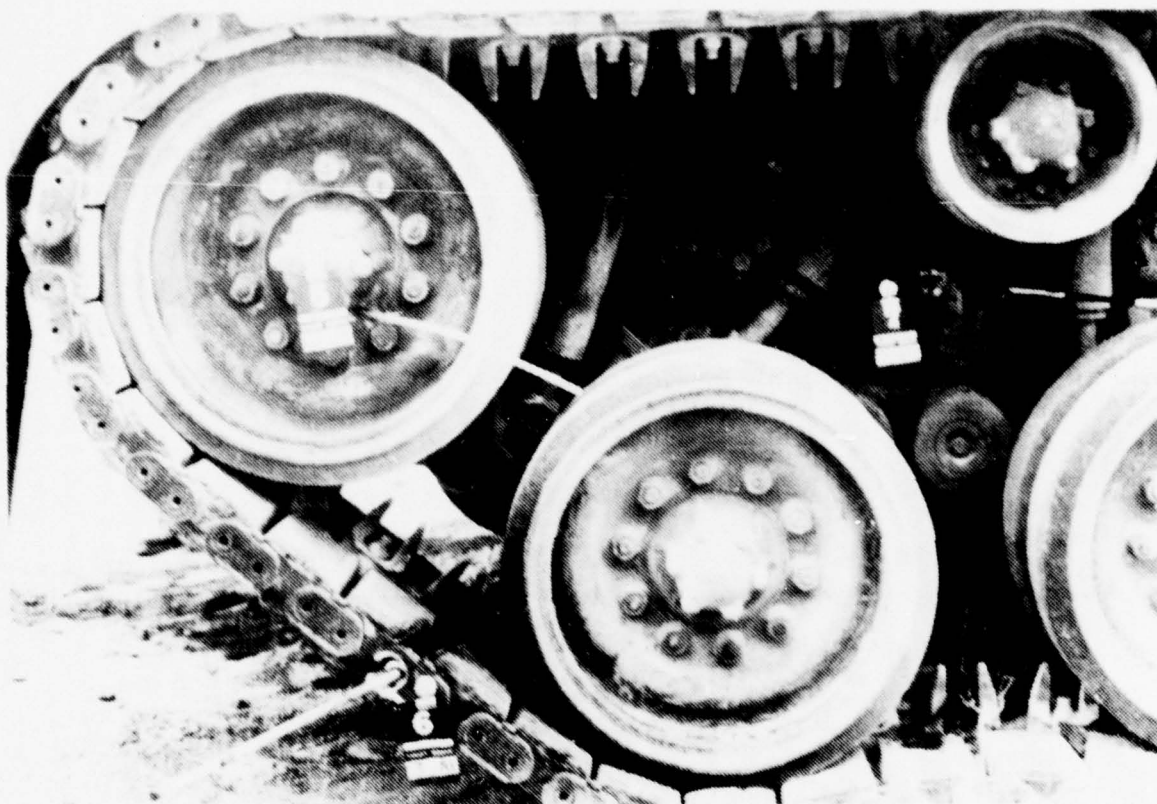
4. Rationale for Kill Assessment:
 - a. M-Kill: 100% M-Kill due to track adjusting idler wheel damage resulting from Impact 5 (Figure 14) driver casualty inflicted by Impact 7 (Figure 15).
 - b. F-Kill: 40% F-Kill based on driver casualty criteria, possible loss of power elevation and traverse, and penetration through the gun tube.

FIGURE 14 - TARGET 3
IMPACT 7, PERFORATION OF LEFT HULL INTO DRIVER'S COMPARTMENT
AND IMPACT 5, PENETRATION OF LEFT IDLER WHEEL HUB

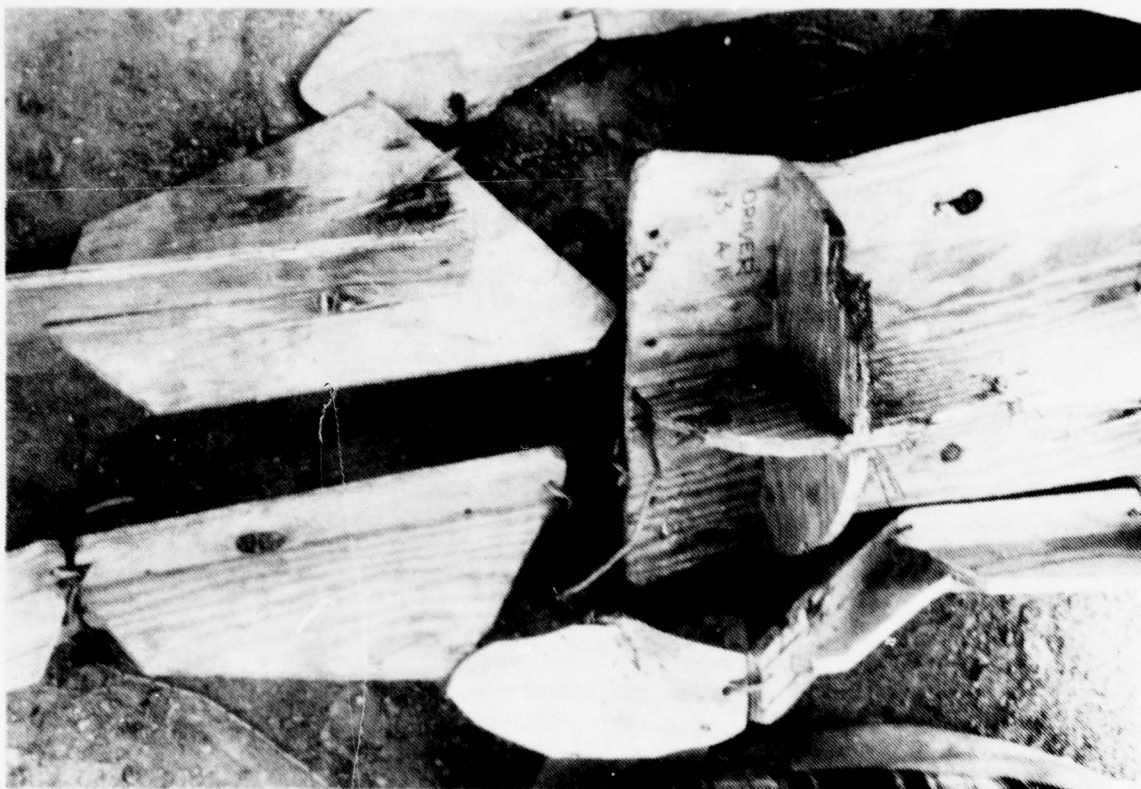
FIGURE 15 - TARGET 3
DAMAGE TO MANNIKIN AT DRIVER'S
STATION CAUSED BY IMPACT NO. 7

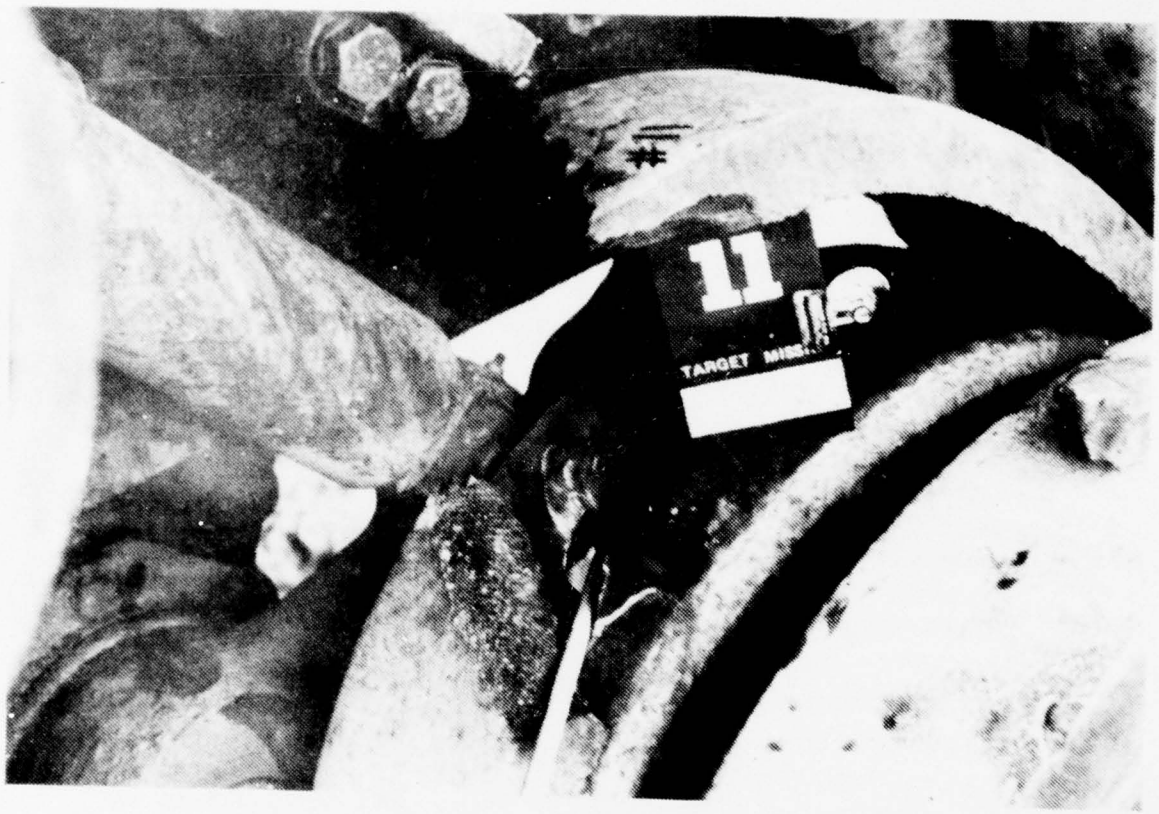
1. Description: Attacked during pass Pl-5 only.
2. Kill Assessment: 5% M-Kill resulting from the following effects:
 - a. Perforations: 0
 - b. Significant Damage: 3
 - c. Insignificant Damage: 9
3. Multiple Pass Assessment: N/A
4. Rationale for Kill Assessment: Light damage to 2 road-wheels, 2 shock absorbers, and 1 track center guide by Impacts 7, 8, and 11. Most severe damage indicated by Impact 11 (Figure 16).

FIGURE 16 - TARGET 4
IMPACT 11, DAMAGE TO RIGHT NO. 1 ROAD WHEEL

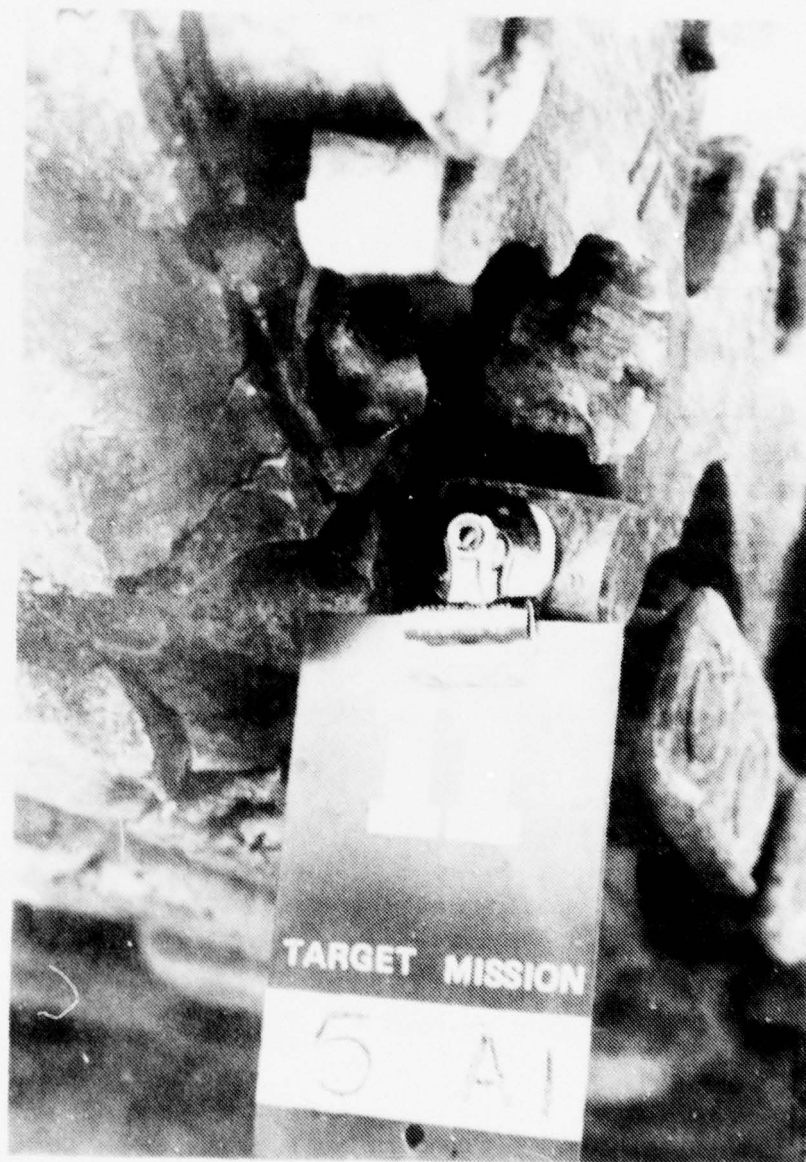
<u>PASS P2-1</u>	<u>PASS P1-4</u>
M - Kill: 5% (Associated with damage resulting from impacts 5, 7 and 8)	M - Kill: 5% (Associated with damage resulting from impact 11)
F - Kill: None	F - Kill: None
4. Rationale for Kill Assessment: Cumulative (5% each pass) damage to track support roller, 2 center guides, 3 tank shoes, 1 end connector, and 1 drive sprocket by Impacts 5, 7, 8, and 11. Most severe damage indicated by Impact 11 (Figure 17).

FIGURE 17 - TARGET 5
IMPACT 11, DAMAGED TRACK SHOES, END CONNECTOR AND
DRIVE SPROCKET

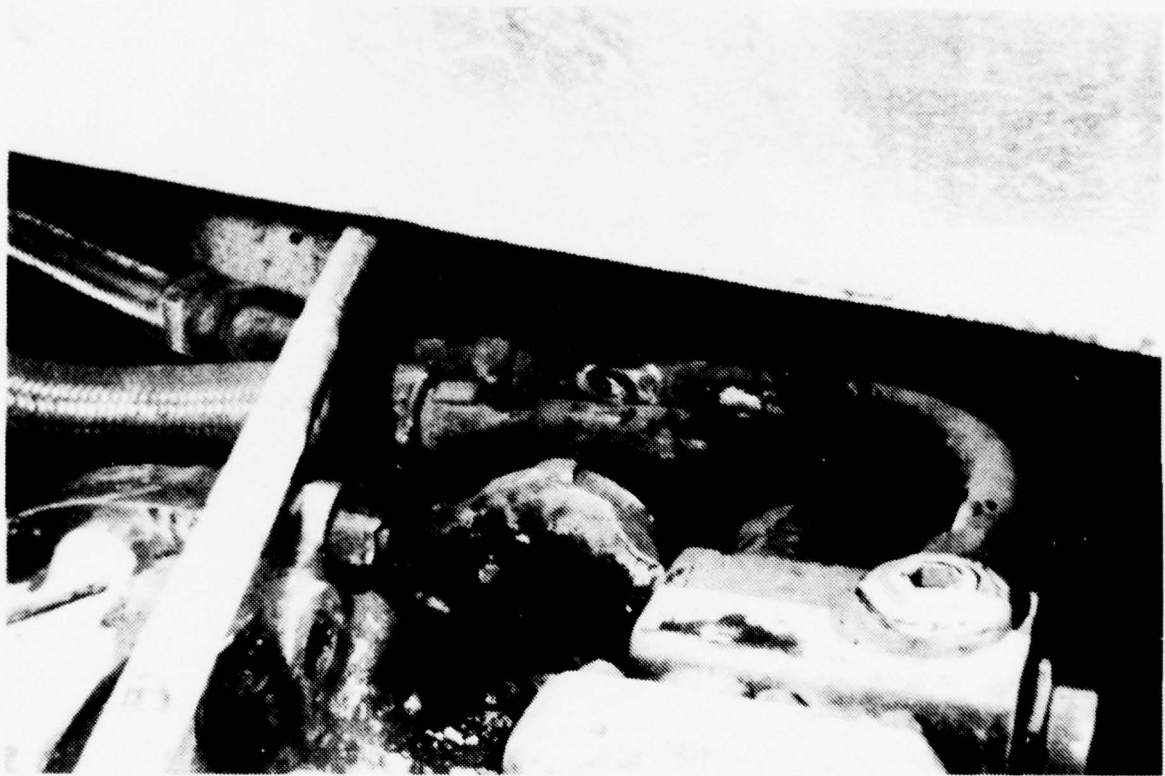
1. Description: Attacked during pass Pl-3 only.
2. Kill Assessment: 100% M-Kill resulting from the following effects:
 - a. Perforations: 1
 - b. Significant Damage: 4
 - c. Insignificant Damage: 8
3. Multiple Pass Assessment: N/A
4. Rationale for Kill Assessment: 100% M-Kill due to perforated transmission oil cooler inlet and outlet lines resulting from Impact 9 (Figure 18).

FIGURE 18 - TARGET 6
IMPACT 9, SPALL FRAGMENT PENETRATIONS INTO
TRANSMISSION OIL COOLER INLET AND OUTLET LINES

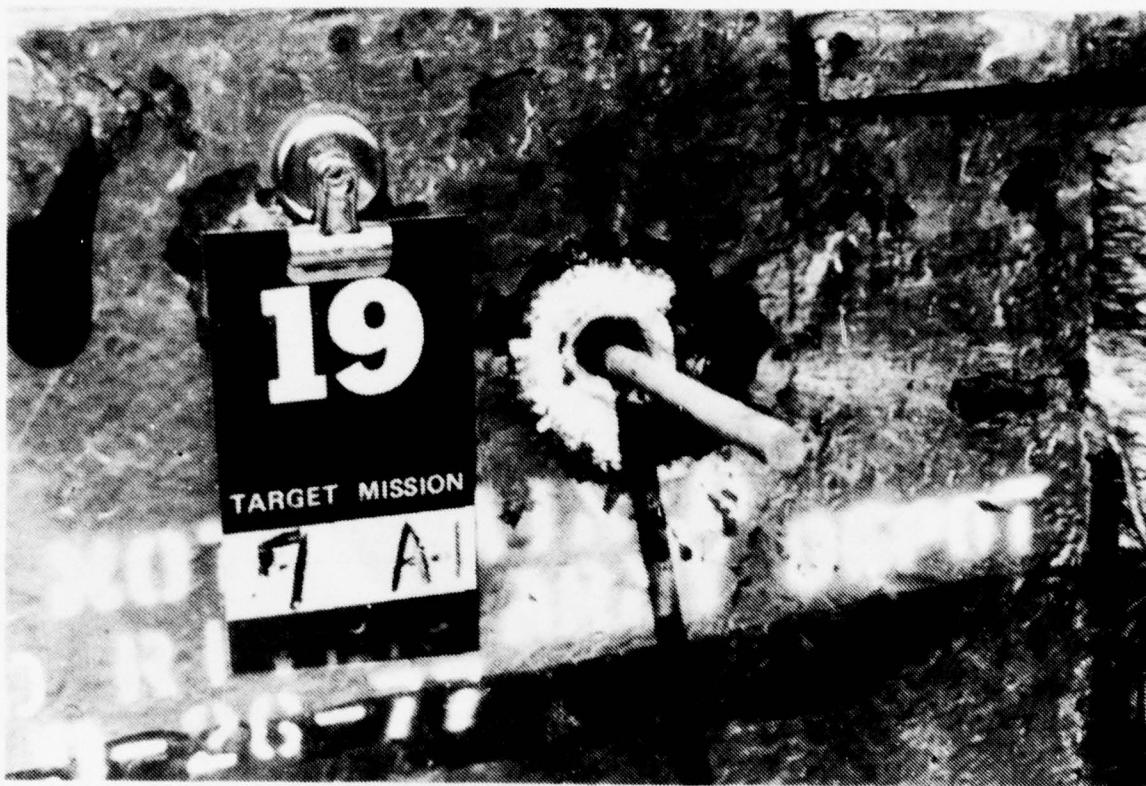
1. Description: Attacked during Pl-2 only.
2. Kill Assessment: 100% M-Kill resulting from the following effects:
 - a. Perforations: 1
 - b. Significant Damage: 7
 - c. Insignificant Damage: 16
3. Multiple Pass Assessment: N/A
4. Rationale for Kill Assessment: 100% M-Kill due to severed transmission shifting control rod, severed engine oil cooler outlet line, and severed transmission oil cooler inlet and outlet lines resulting from Impact 19 (Figures 19 and 20).

FIGURE 19 - TARGET 7
IMPACT 19, PERFORATION INTO ENGINE COMPARTMENT

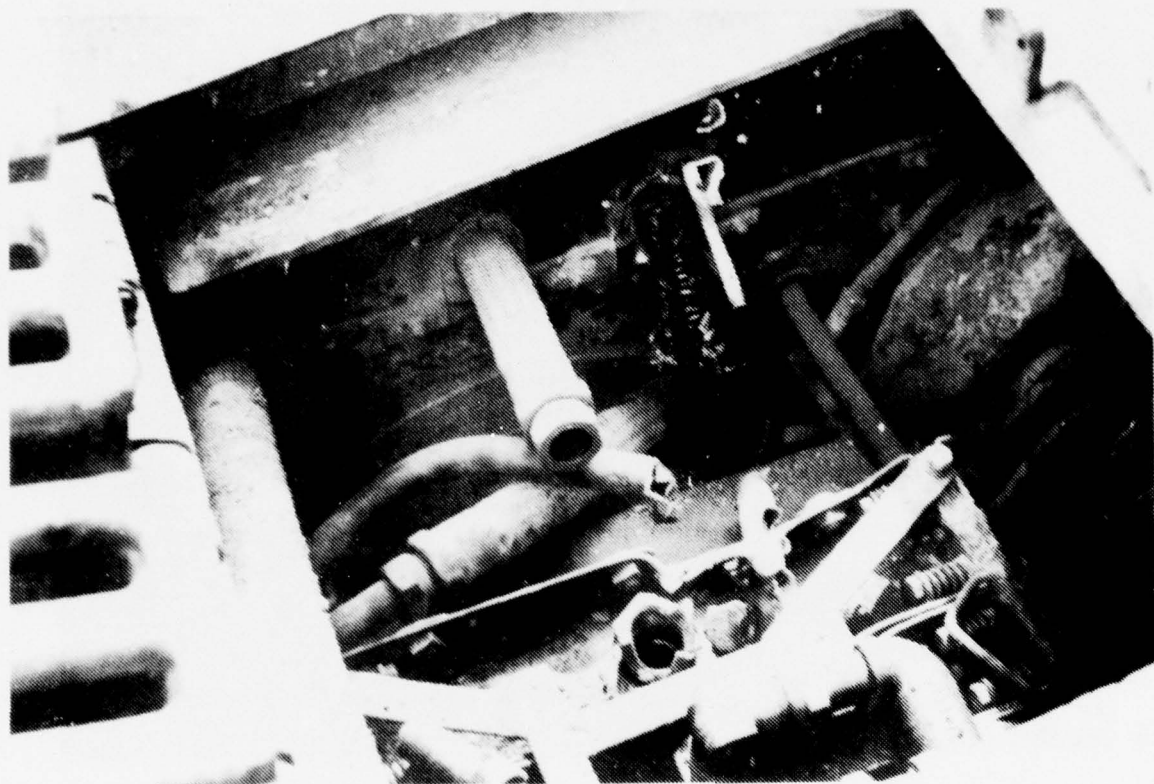
FIGURE 20 - TARGET 7
SEVERED OIL COOLER INLET AND OUTLET LINES, IMPACT NO. 19

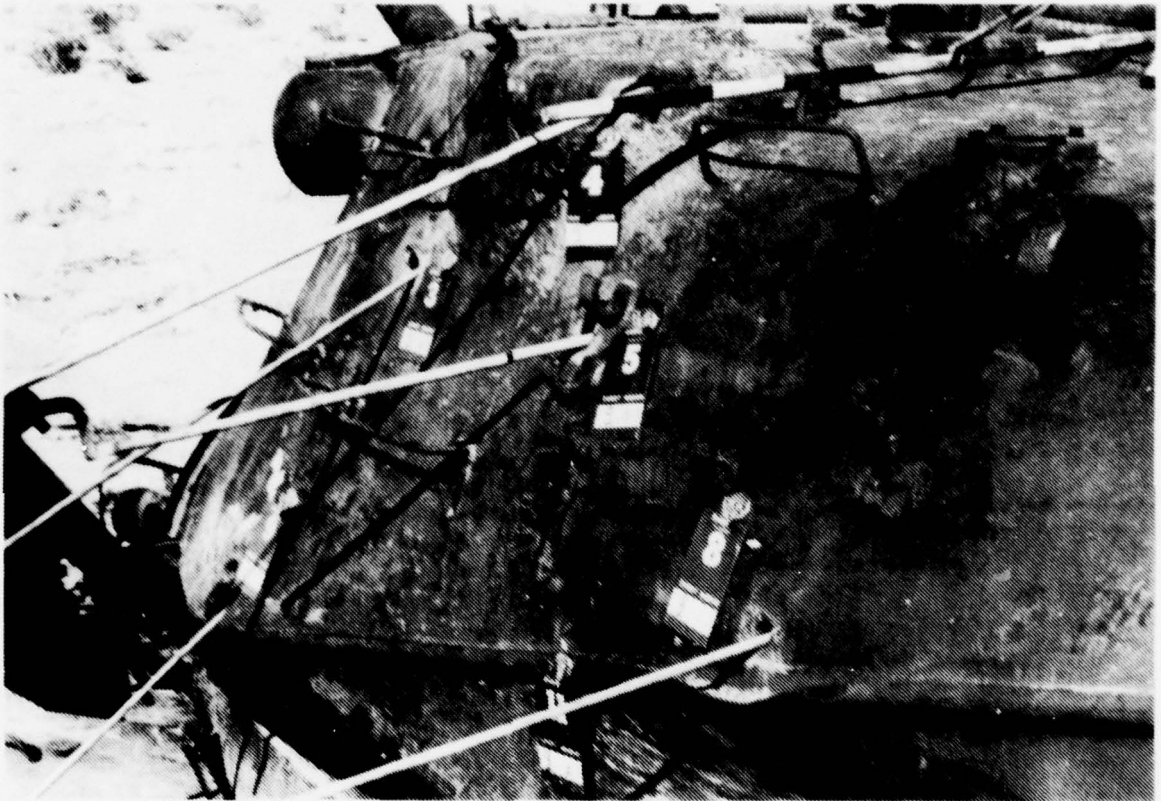
1. Description: Attacked during passes P2-1, P2-3 and one unidentified pass. Kill could not be attributed to a specific pass.
2. Kill Assessment: 100% K-Kill resulting from the following effects:
 - a. Perforations: 9
 - b. Significant Damage: Omitted - Catastrophic fire and explosions override other damage.
 - c. Insignificant Damage: Omitted - Catastrophic fire and explosions override other damage.
3. Multiple Pass Assessment: Not Possible
4. Rationale for Kill Assessment: 100% K-Kill due to multiple perforations into the fighting compartment (2), driver's compartment (2), and hull (5), which caused at least 4 crew casualties, two penetrations into the left bulkhead ammunition stowage area, and one penetration into the left fuel tank (Figures 21, 22, and 23).

FIGURE 21 - TARGET 9
IMPACTS 5 AND 8, PERFORATIONS OF LEFT
TURRET INTO FIGHTING COMPARTMENT

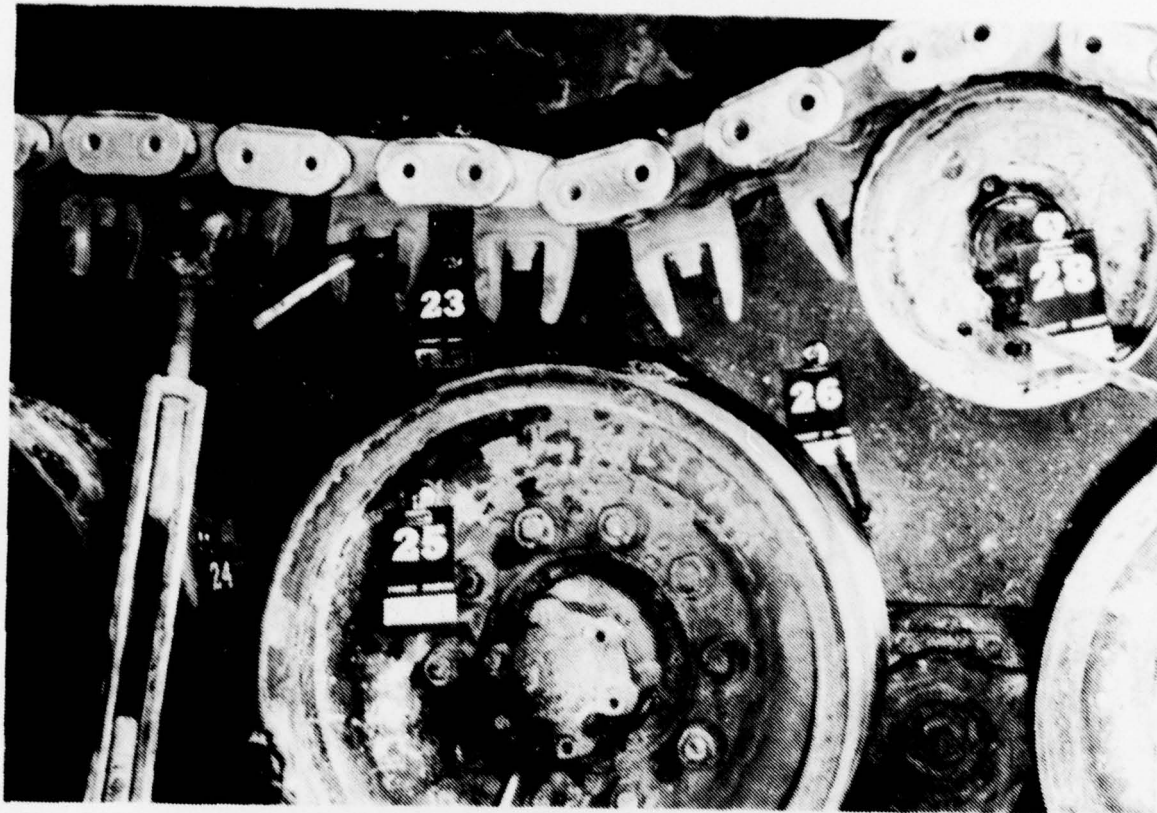
FIGURE 22 - TARGET 9
IMPACTS 23 AND 26, PERFORATIONS OF LEFT HULL INTO BULK-
HEAD AMMUNITION STOWAGE COMPARTMENT

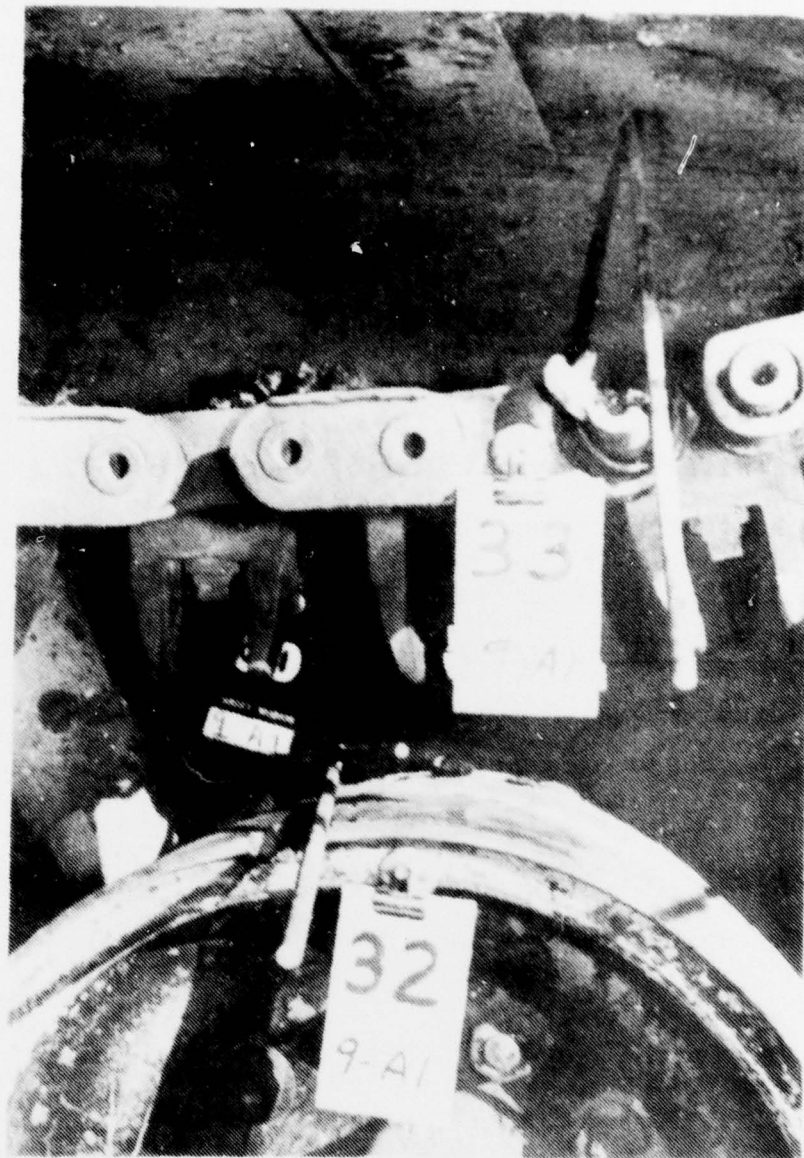
FIGURE 23 - TARGET 9
IMPACT 30, PERFORATION OF LEFT HULL
INTO LEFT FUEL TANK

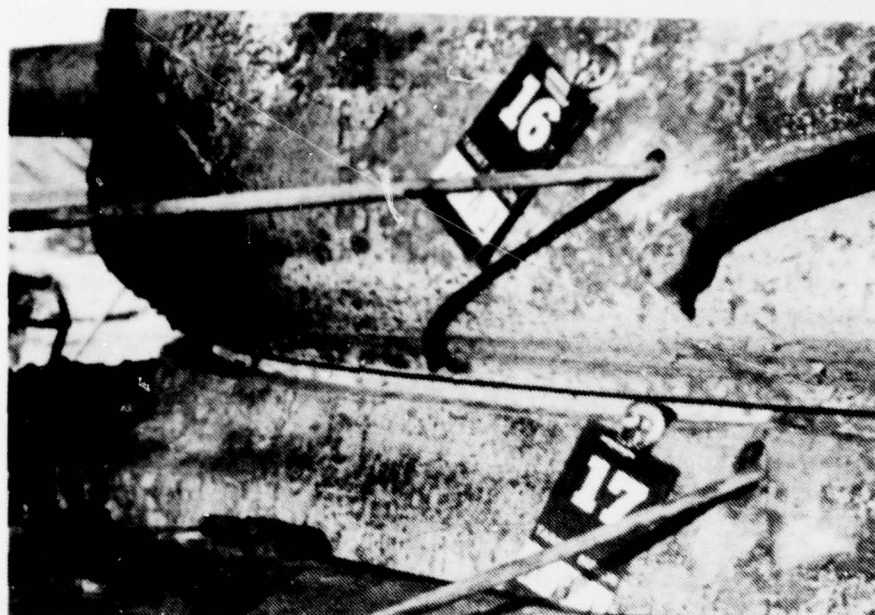
1. Description: Attacked during pass P2-1 only.
2. Kill Assessment: 100% K-Kill resulting from the following effects.
 - a. Perforations: 11
 - b. Significant Damage: Omitted - Catastrophic fire and explosions overrides other damage.
 - c. Insignificant Damage: Omitted - Catastrophic fire and explosions overrides other damage.
3. Multiple Pass Assessment: N/A
4. Rationale for Kill Assessment: 100% K-Kill due to multiple perforations into the fighting compartment (4) and hull (7) which caused at least 3 crew casualties, one penetration into the left bulkhead ammunition stowage area, two penetrations into the left fuel tank, and three penetrations into the engine compartment (Figures 24 and 25).

FIGURE 24 - TARGET 10
IMPACT 16, PERFORATION OF LEFT TURRET
INTO FIGHTING COMPARTMENT

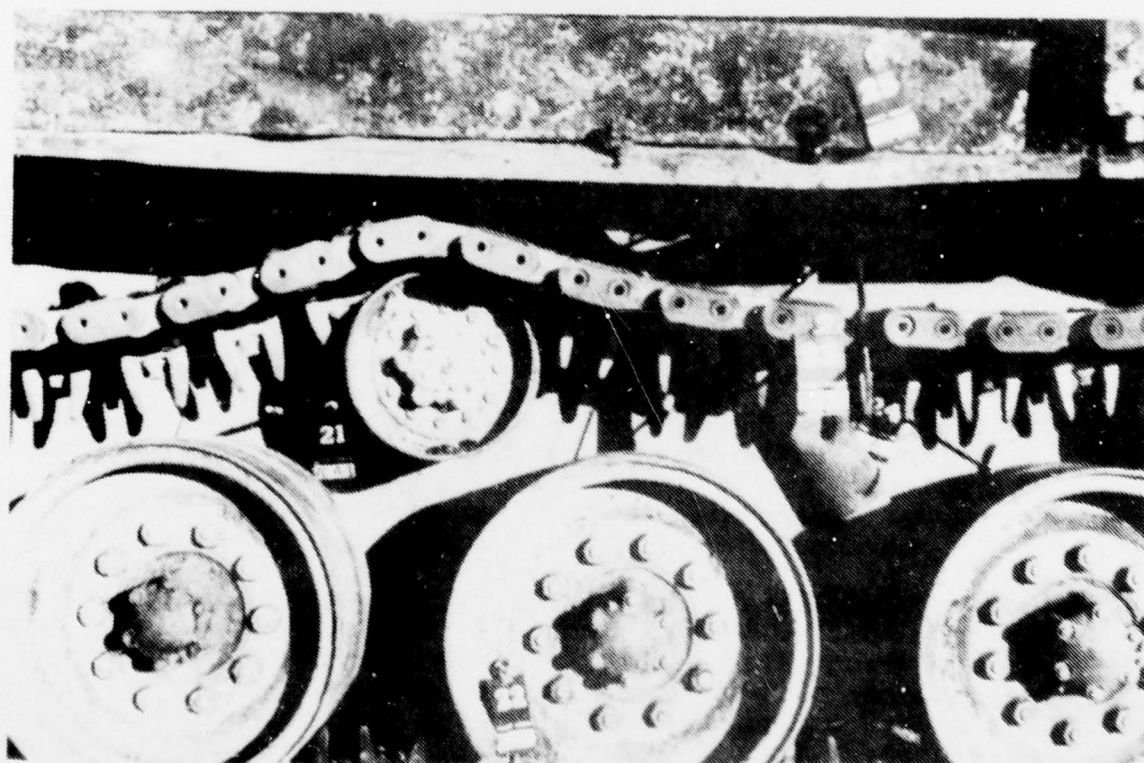
FIGURE 25 - TARGET 10
IMPACTS 24 AND 25, PERFORATIONS OF LEFT
HULL AND PENETRATIONS INTO THE LEFT FUEL TANK
